# GODDARD SPACE FLIGHT CENTER

## Evaluation Report

Microcircuit (10)  
Mfr.: MICREL  
P/N: SY89424VZC  
D/C: 9910

Project  
VCL  
System  
Parts testing  
Requester  
K.Sahu (562)  
Initiated Date  
10/01/00  
Investigator  
A.Teverovsky (562)

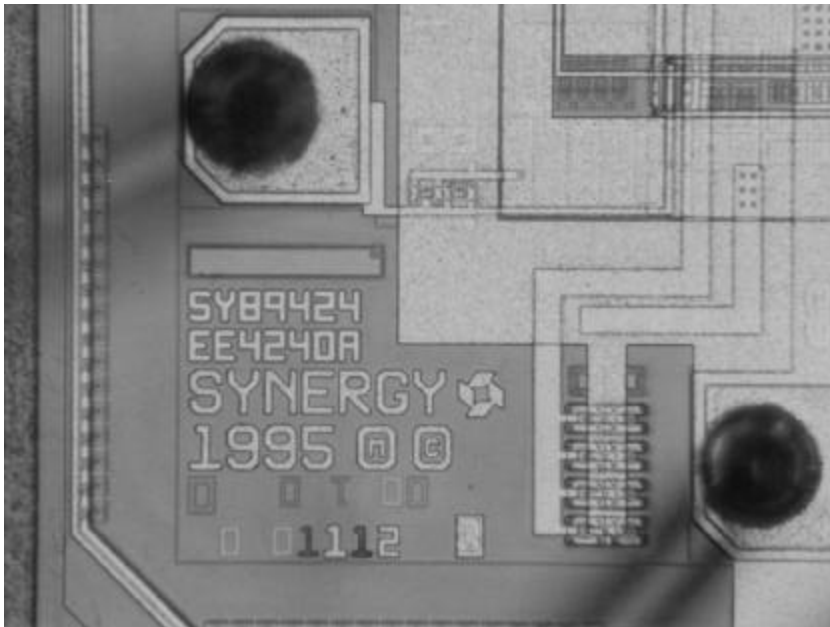
Figure 8. Overall view of the part after decapsulation.

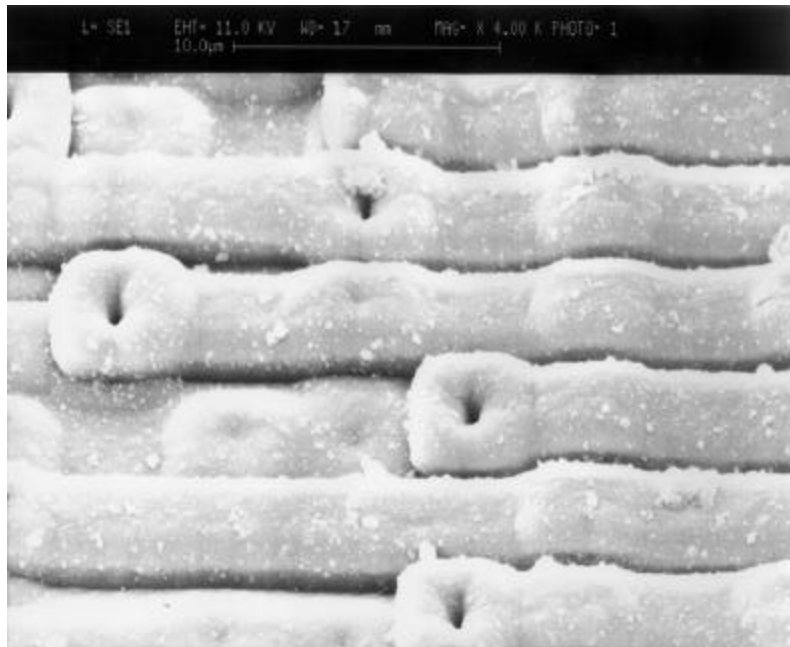
This examination was performed on one sample per MIL-STD-883D, Method 2021, "Glassivation layer integrity". The test involved a high-power optical examination after the die was subjected to aluminum etch. Aluminum etching revealed one crack in the glassivation (see Figure 11). However, detailed SEM examination of the glassivation in another part did not reveal any defects. Figure 12 shows typical SEM view of the glassivation.

Figure 11. A crack in the glassivation revealed during the glassivation integrity test. (500X)

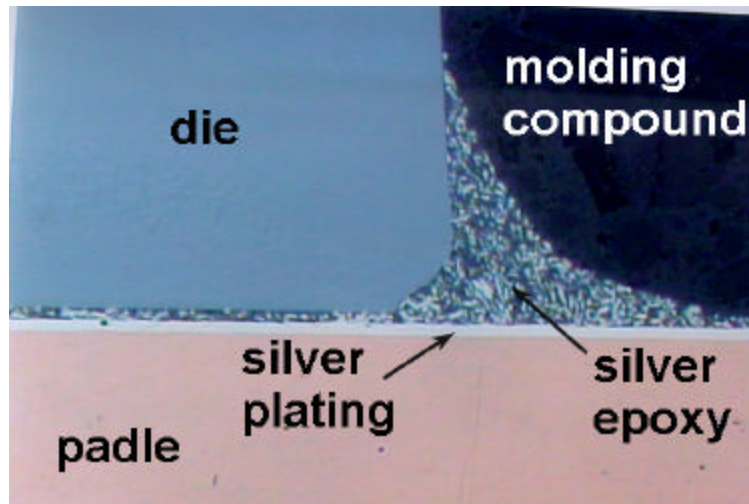
The molding compound had no internal cracks or voids and formed intimate contacts to all internal surfaces (die, wires, and lead frame). No delaminations between the glassivation and the molding compound were observed.

Figure 15. An overall view of the package cross section.
